When instruments lie

The crew of a 737 narrowly averts a fatal accident after their engine instruments malfunction during take-off.

John Laming

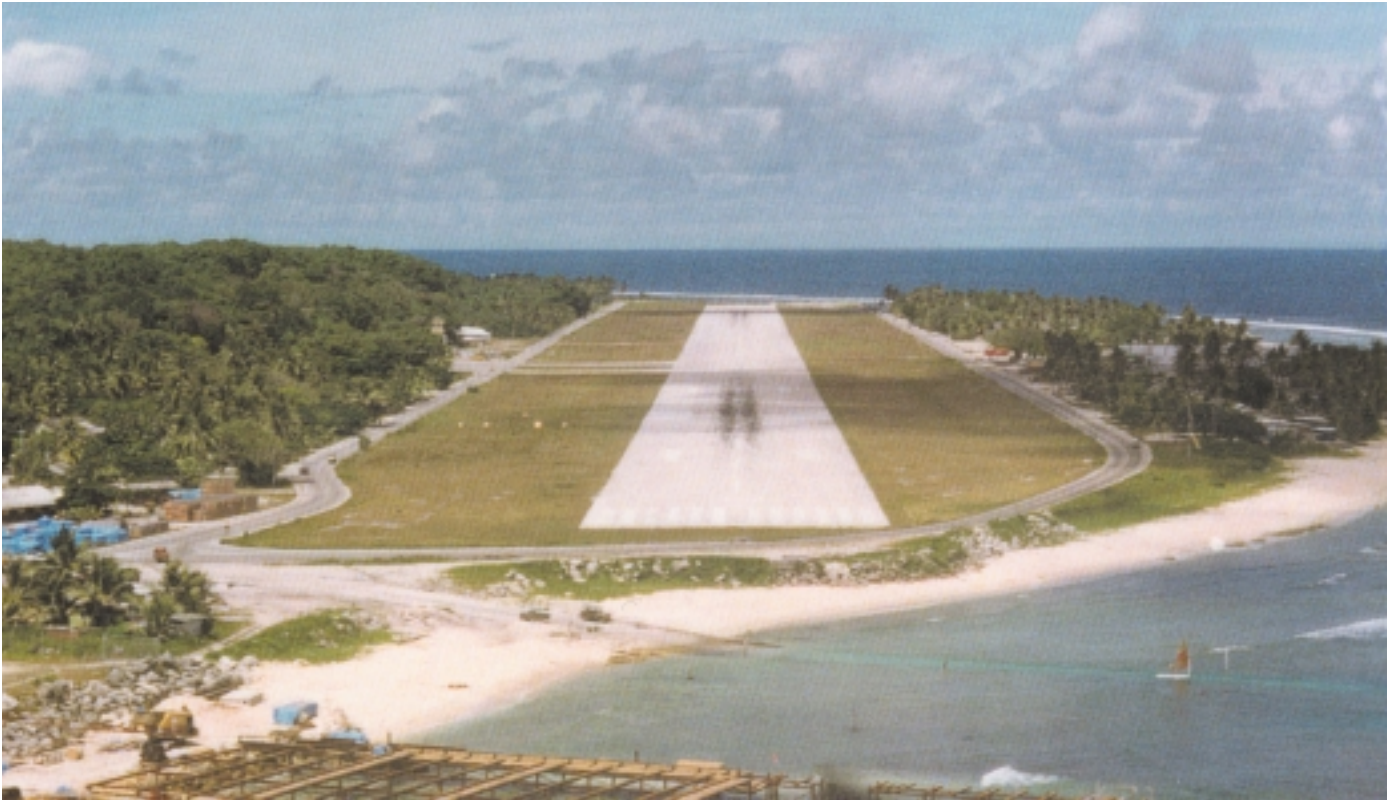
Nauru airport: The 737 lifted off 15 knots below the calculated rotation speed, and flew just 19 feet above the sea for several hundred yards before gradually climbing away.

The flight data recorder (FDR) later revealed that the aircraft had lifted off 15kt *below* the calculated rotate speed, and had flown just 19 feet above the sea for several hundred yards before gradually climbing away. We never did see the towering metal structure of the phosphate cantilevers that passed above our altitude, 200 yards to the right of the extended runway centreline...

AFTER landing, the cause of the trouble was soon discovered. The PT2 tubes of both engines – the sensors that gave the vital EPR readings for take-off – were blocked, not with ice but with congealed phosphate dust and some other glutinous substance. It was impossible to determine the precise time that the tubes became blocked, or how the substance found its way into the system.

Later calculations showed that the actual power on take-off was around 2.05EPR, even though the EPR needles were steady at 2.18. That power would have been ample for a long runway, and in fact was a setting frequently used for the right combination of runway length and gross take-off weight.
